AGARD Corrosion Handbook Volume 1 Aircraft Corrosion: Causes and Case Histories

AGARDograph No.278
AGARD CORROSION HANDBOOK
VOLUME 1

AIRCRAFT CORROSION: CAUSES AND CASE HISTORIES

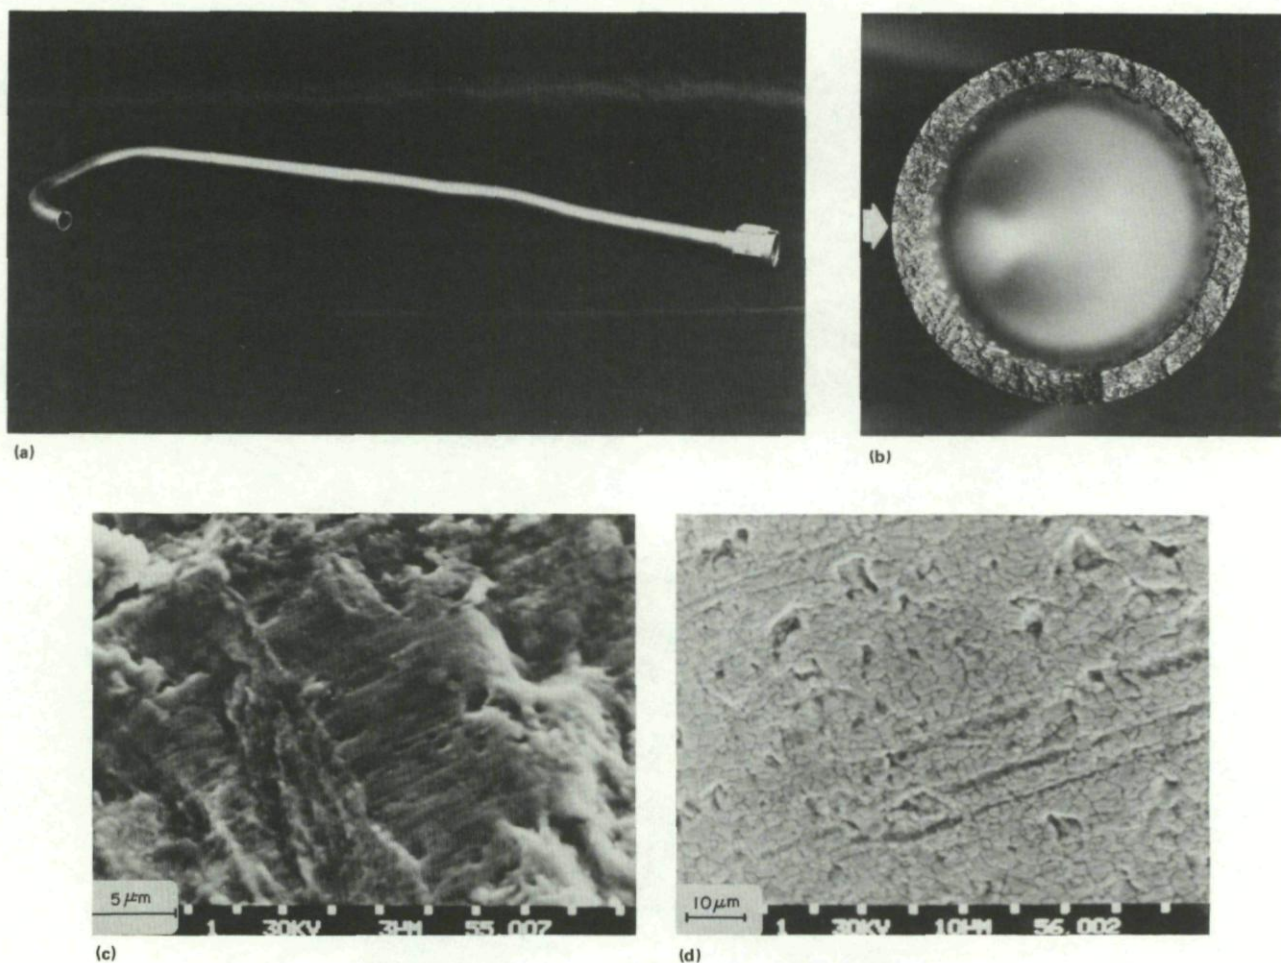
Fig. 14-14 Corrosion fatigue of a 321 stainless steel hose assembly

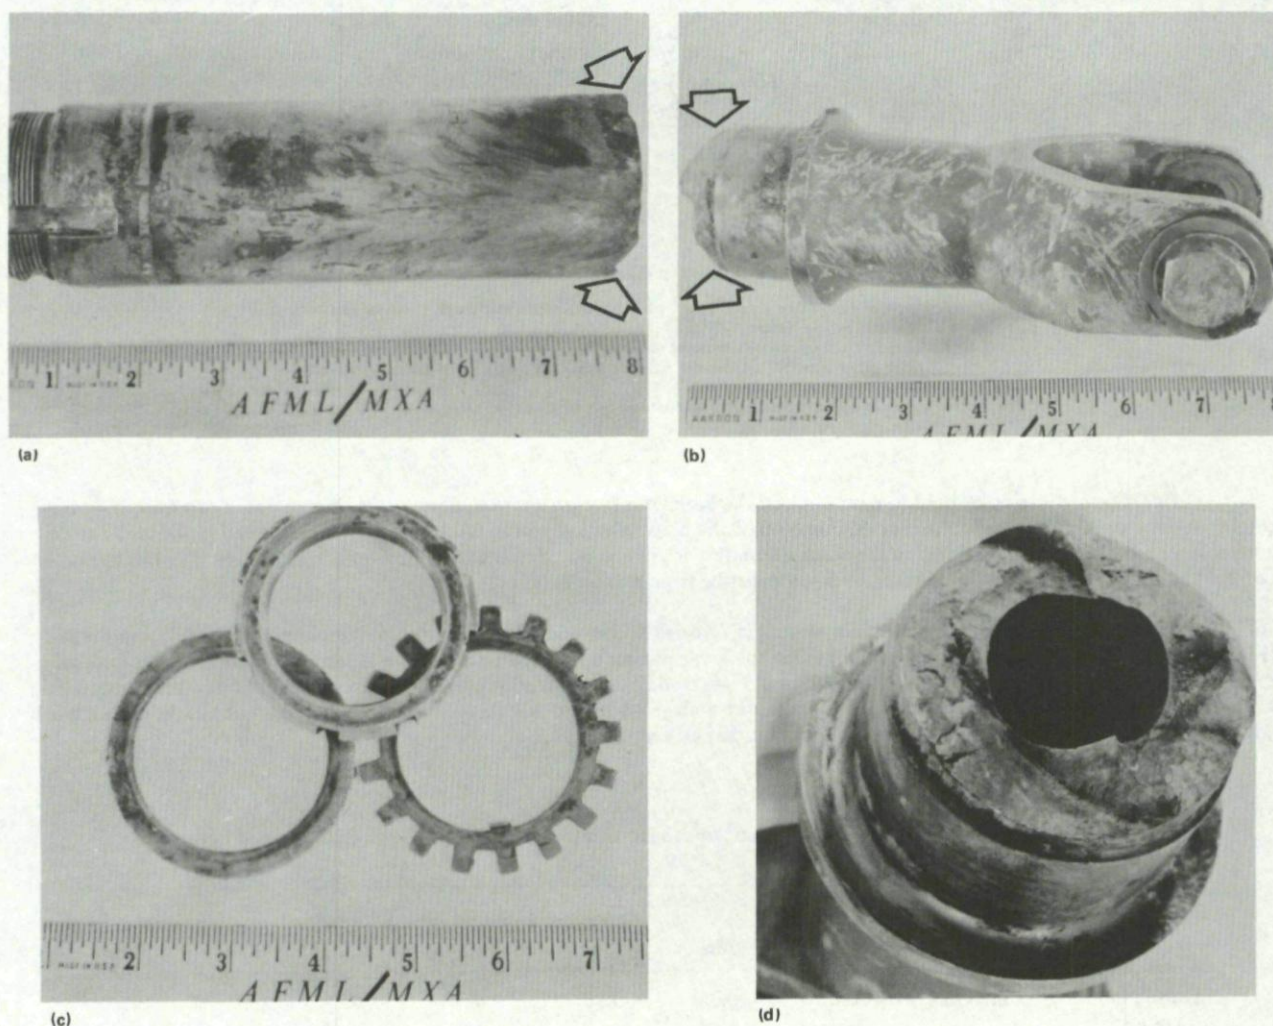
Fig. 14-15 Corrosion fatigue of a 4340 steel rotor attachment assembly

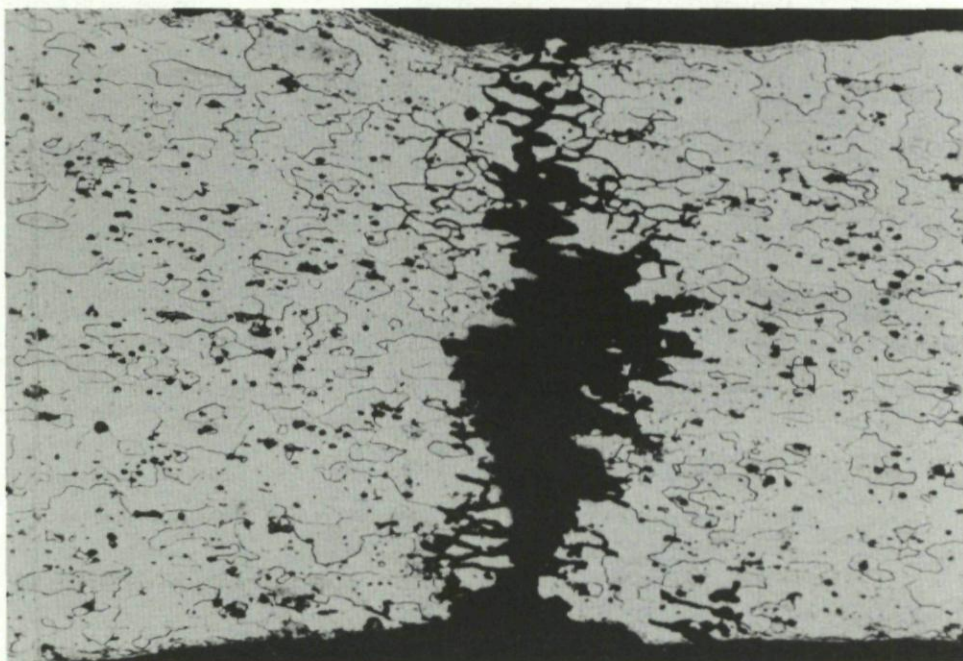
Fig. 15-6 Typical perforation corrosion caused by micro-organisms. Alloy: 2024 (Al-Cu-Mg)

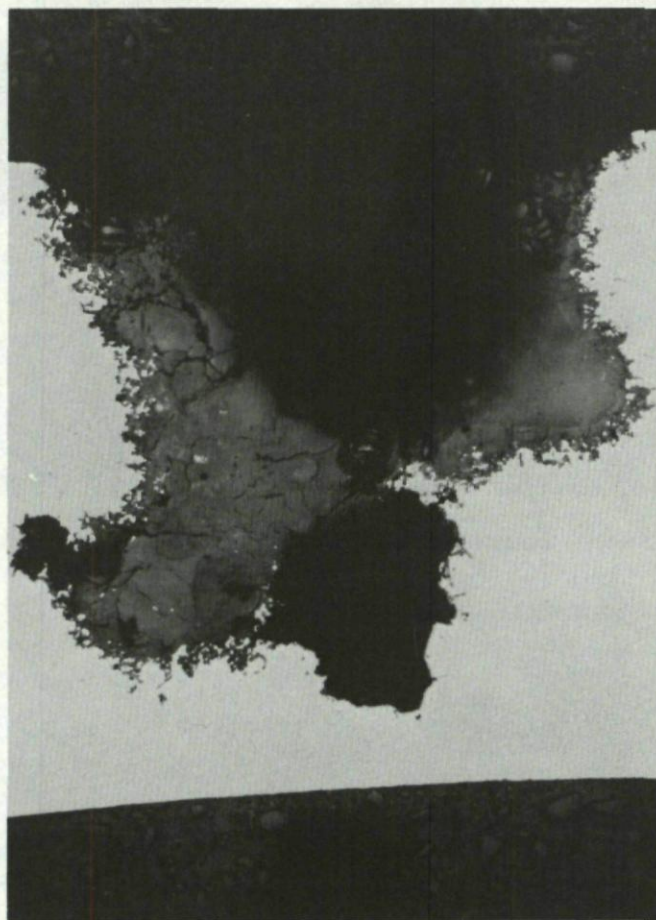
Fig. 15-7 Typical microbiological corrosion.
Alloy 5052 (Al-Mg)

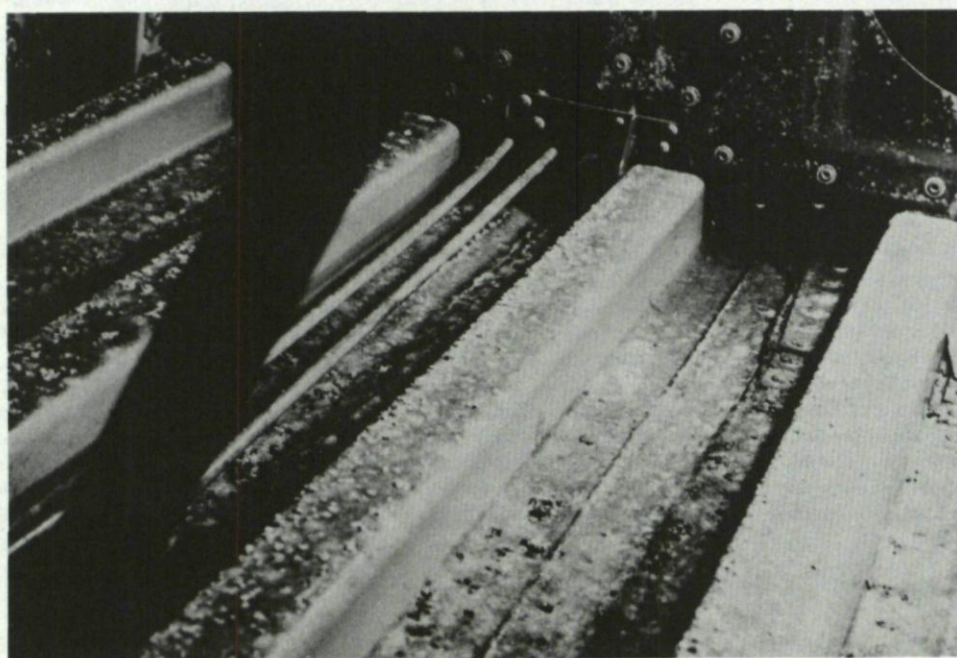
Fig. 15-8(a) Typical view of integral fuel tanks with microbiological corrosion

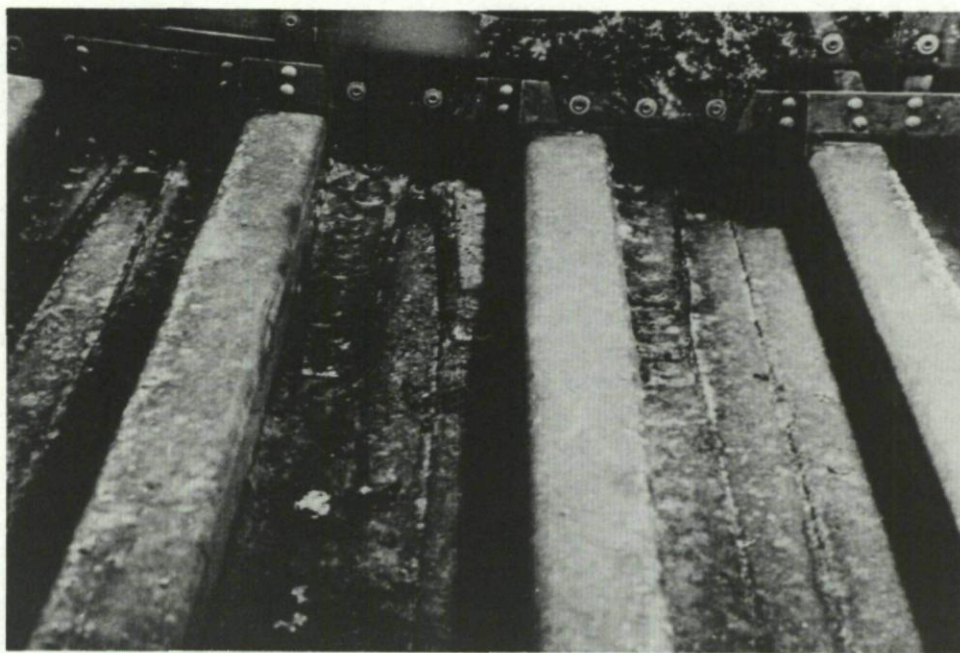
Fig. 15-8(b) Typical view of integral fuel tanks with microbiological corrosion
